Bristol Austin Seven Club

Bristol Austin 7 Club - technical article

Sock absorbers - Ron Hayhurst

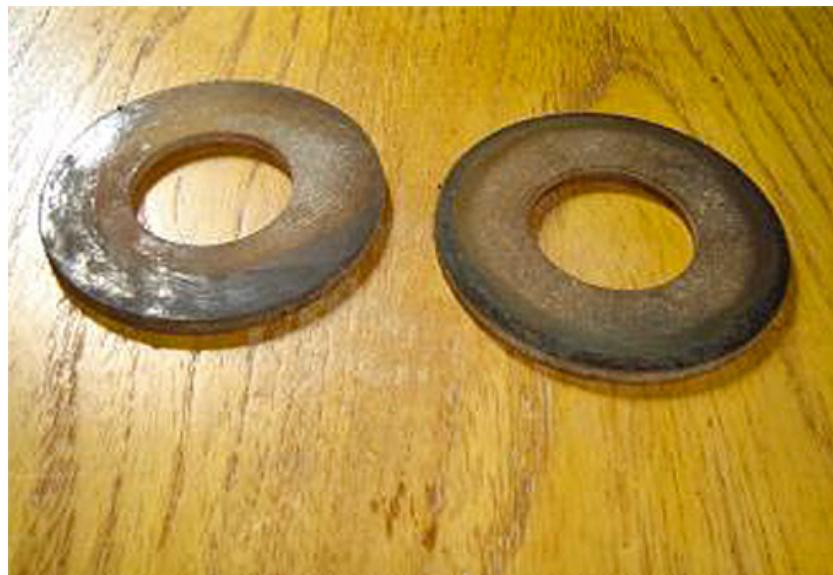
I started by removing the two nuts in the centre and, in separating the arms, soon found the rubber bushes to be badly worn - as was the side of the aluminium link. The eye opener was to discover just how little of the discs was in contact with the friction face of the two outer arms, as shown in Picture1. For whatever reason, the friction face of these two arms was found to be concave. Consequently it had been in contact across a ring only 3mm wide at the outer edge of the disc. The rest of the discs had never been in contact. Problems were also seen on the faces of the centre bracket, which bolts to the chassis, and on the associated discs and offside arms.

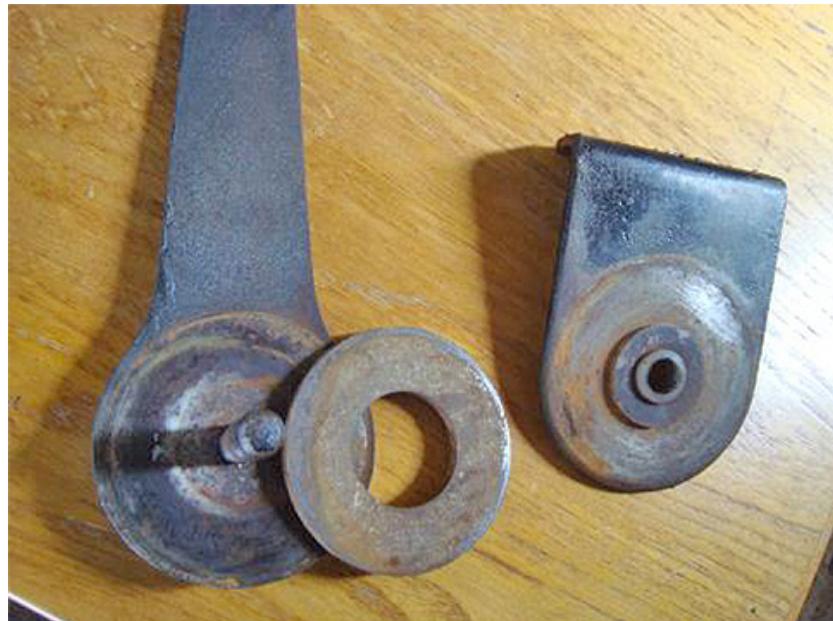
Picture 2. shows how rust and glazing had also lead to a reduced damping effect, although in general terms all faces were parallel. The flat face of the centre bracket was restored using a Rexon belt sander and the reverse side and the

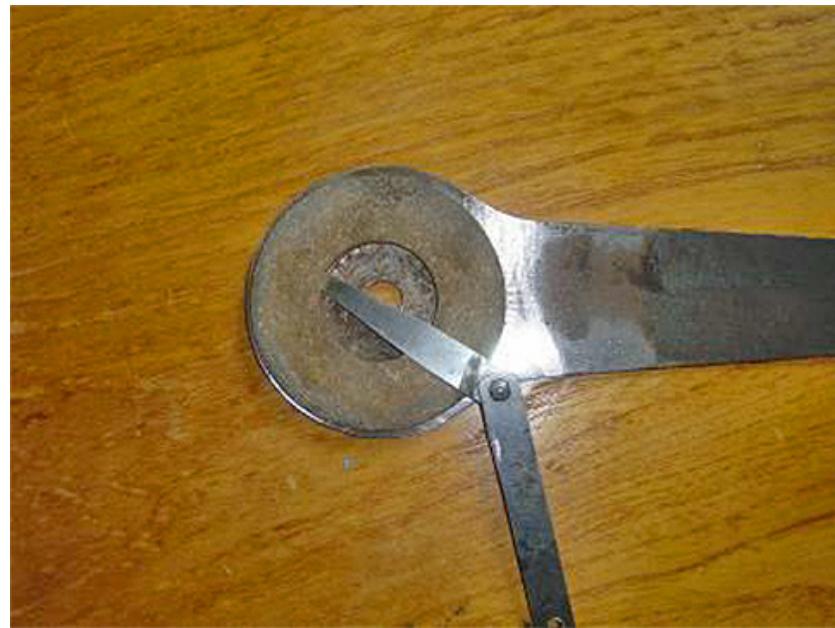
check with feeler gauge

faces of the centre arm, which have raised bosses, were cleaned up with emery cloth. Making checks with a feeler gauge as seen in Picture 3 gave some idea of the need to take metal off the arms until a parallel face was produced. The belt sander was again employed and, after an initial attempt, the outer unworn part was removed as seen in Picture 4. To remove the remainder took some time, including interruptions to cool it down, until fully "flattened" as in the final picture [overleaf].

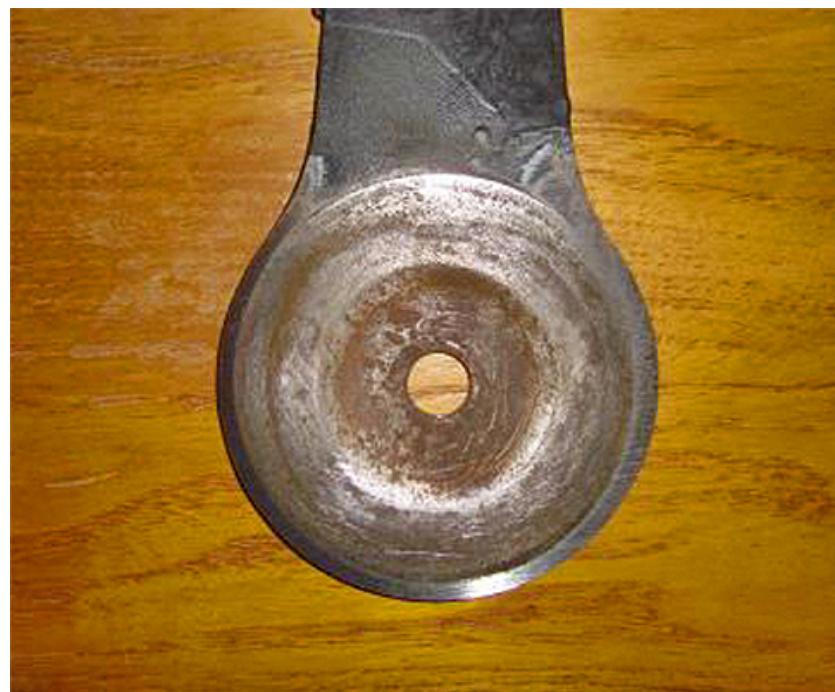
arm after initial sanding

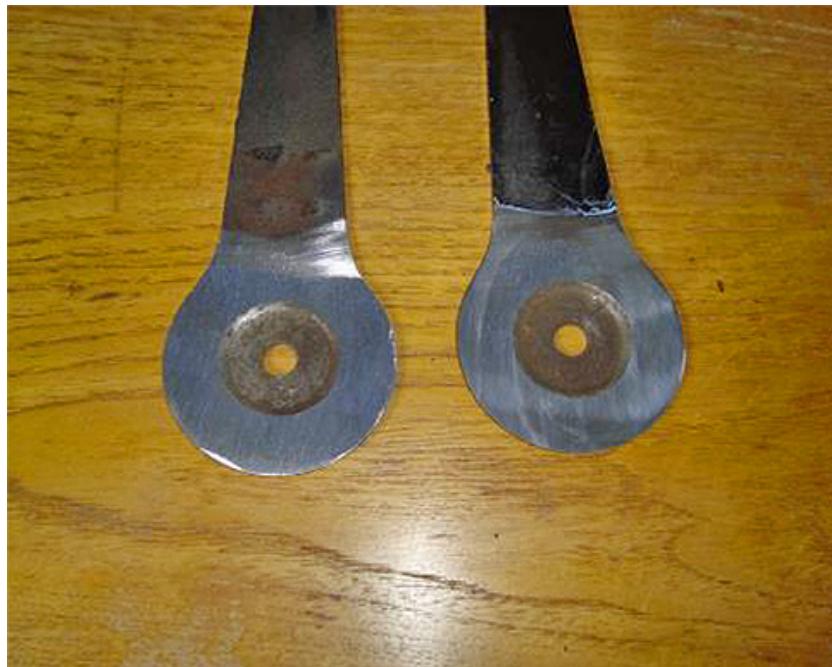
arm after initial sanding
