Bristol Austin Seven Club

Bristol Austin 7 Club - technical article

Steering - drag link refurbishment - by Ian Moorcraft

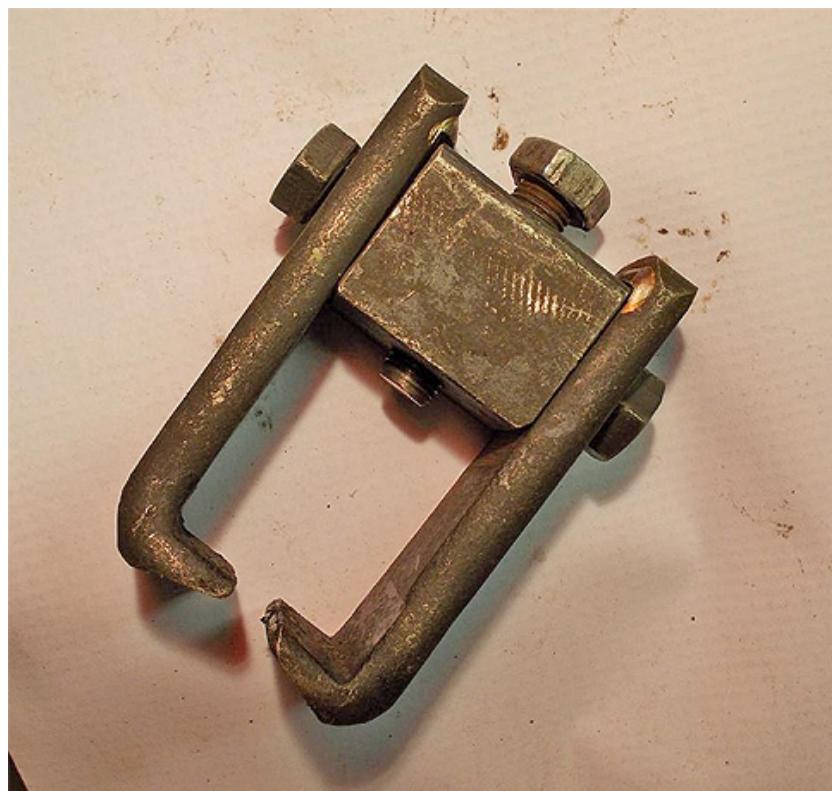
Its best to remove the assembly from the car, so start by removing the split pins and castellated nuts from both the ball pins. You will need a suitable puller (I don't like hammering old metal, especially on anything to do with the steering) to remove the ball pins from the steering box drop arm and the steering arm as they are on a taper fit and can sometimes be very tight. Pic. A shows one I made up for the job many years ago.

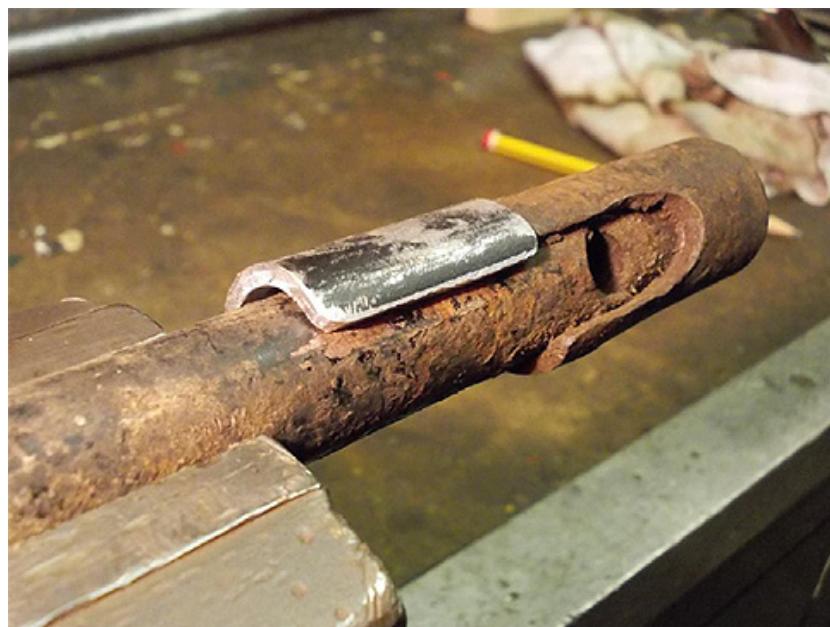
Undo the $\frac{1}{4}$ " bolts that hold the end caps on, first defect is likely that the threads are shot due to them being hammered in with the end caps misaligned by our bodger friend on a previous occasion, replace with new.

Pic. B shows a half round aluminium drift I use for removing the end caps without damage. Recover the chamfered thrust disc and any packing washers or shims (Pic. C) as well as the loose thrust block from each end of the drag link, it never ceases to amaze me what you find inside, one I stripped for this article had 6 spring washers instead of a spring and another had a valve spring cup instead of the chamfered disc, and even a pair of metal coat buttons in the one that was on my Chummy, they had obviously covered many miles like that so what 'can' you say!

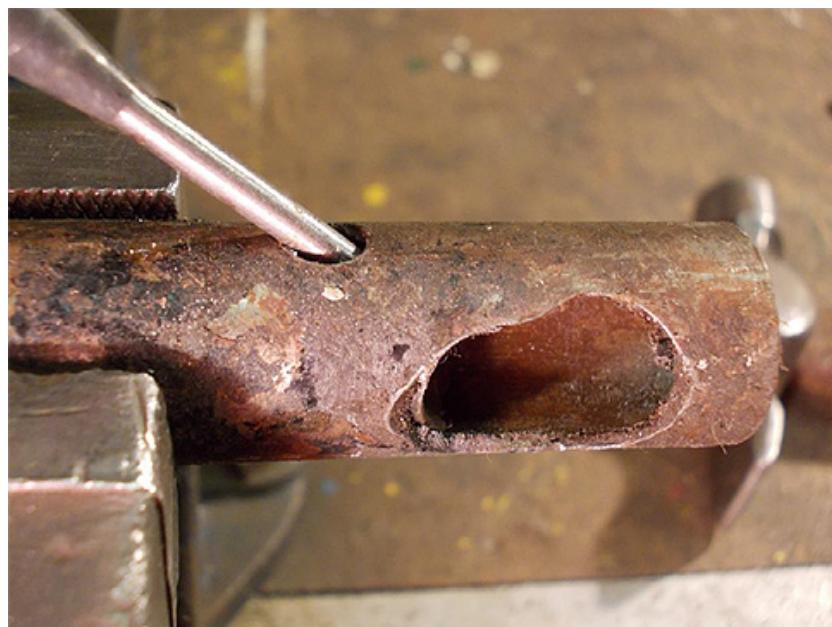
Now for the hardest part of the job: removing the fixed thrust blocks. If you are lucky they may just fall out by banging the end of the shaft on the bench. Try this at both ends as you only need to get one out to enable you to put a rod inside the tube and knock the remaining one out. Likely as not they will both be rusted solid with no visible means of removal.

Pic. D shows an 1/8" punch held on an angle inside the bolt hole to knock the fixed block forward as much as possible before the hole closes up on the punch. Get yourself a proper punch as 3" nails and drills just will not do the job if they are really tight.

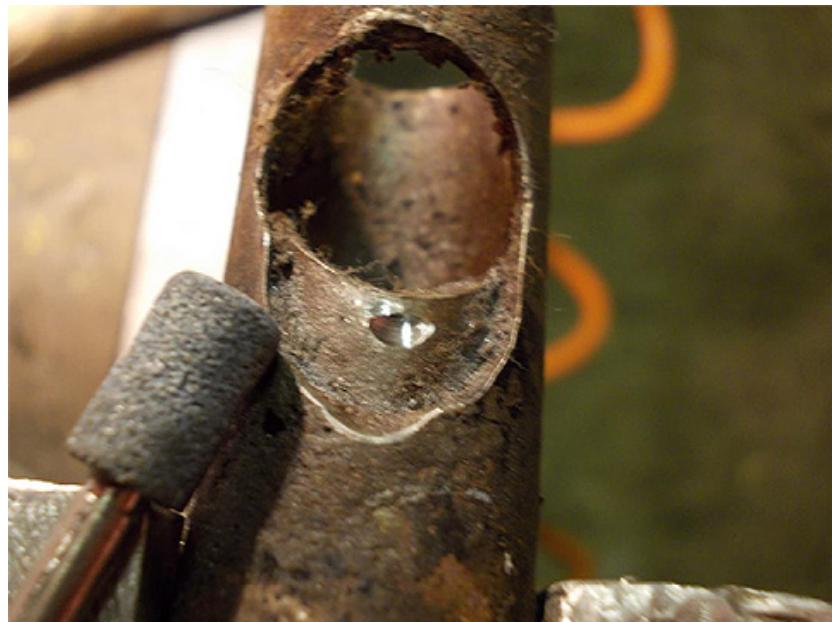
Pic. E shows the front edge of the thrust block that has now moved forward enough to grind a small notch into it, this will allow you to use the punch in the notch to drive the block forward a little more.

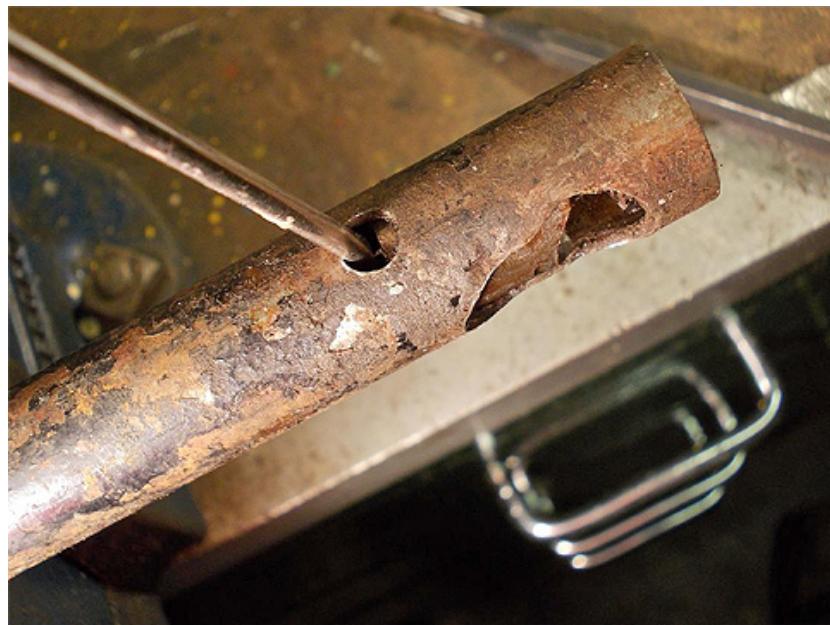
Pic. F shows a screwdriver against the other end of the block revelled in the bolthole to lever it forward and out. Drop the punch into the tube and shake it up and down knocking the other one out of the opposite end. If this fails you will need a long rod to punch it out.

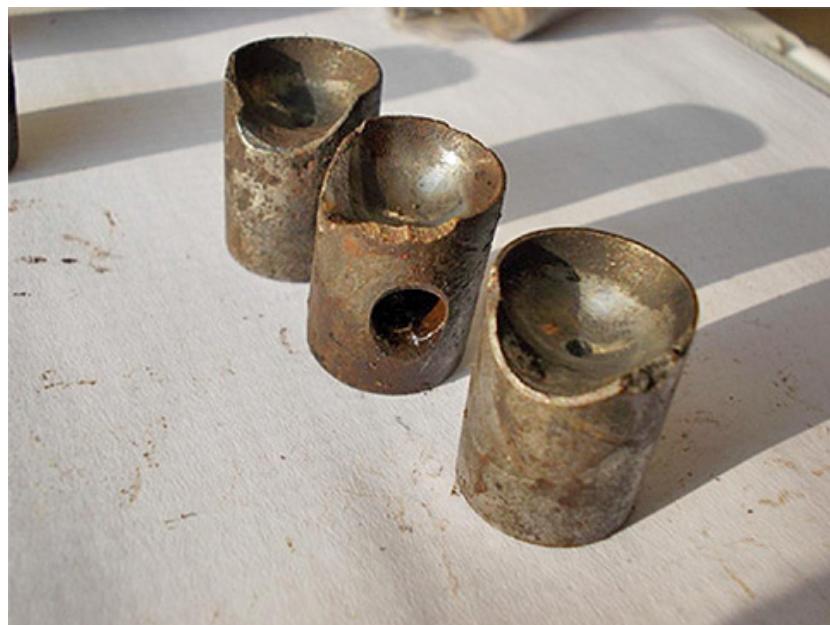
Pic. G

Next have a good clean up and thorough inspection, hold the tube up to the light and look inside for rust pitting (unlikely) check the ball pins are round (unlikely, the ones on this one were worn 60 thou. oval with deep grooves worn in the

necks) check the four thrust blocks for chipping and wearing thin on the edges as shown in (Pic. G) check springs for compression and breakages (Pic. H). So if this was the case chuck the lot in the bin and buy new ball pins thrust blocks and springs. The chances of the result being any different than this is unlikely so I suggest you buy the bits before you start!

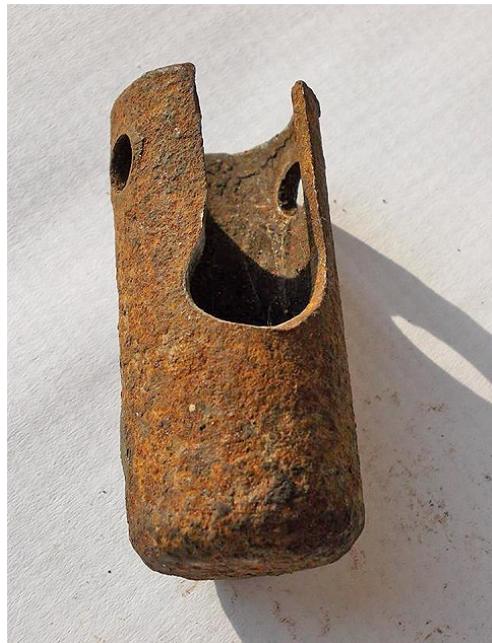
Pic. J

The next thing to do is inspect the 'keyhole' slots in each end of the tube, they are unlikely to have any cracks but do check for rust thinning on the tube ends as the last couple of inches are machined with an undercut to give location for the fixed blocks and are therefore thinner than the rest of the tube. The edges of the 'keyhole' slot will probably have worn to a knife-edge in places (this can wear a groove in the neck of the ball pin), lightly file back to thicker metal with a nice rounded edge. When finished should look like (Pic. I) Note: you should not be able to put the new ball pin though the narrow ends of the slot, if you can, get another draglink. Dress any lumps around the bolt holes and run a $\frac{1}{4}$ " drill through the holes and deburr.

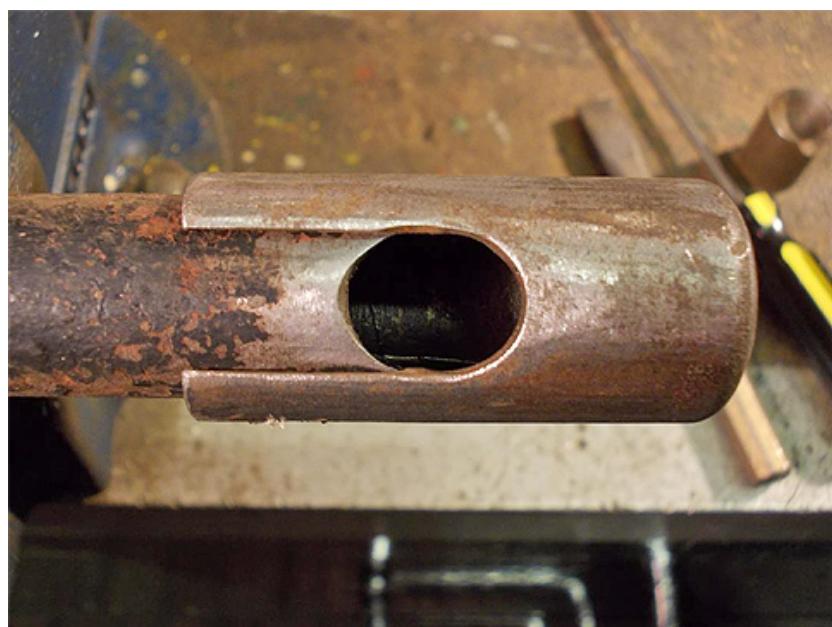
Pic. K

Turning to the end caps, as mentioned previously they are likely to have been butchered in the past. File the ends flat, clean up the bore and give all of the dents and sharp edges a smoothing off with a fine file, also pay particular attention to the edges of the slots as if worn sharp these can also cut into the ball pin necks. Dress any lumps around the boltholes and run a $\frac{1}{4}$ " drill through the holes and file down any burrs, they should then slide on and off the tube easily by hand. The slots in the end caps (Pic. J) can wear badly, especially near the end, if it is bad enough to allow the ball pin head to go through (or nearly through) put it in the bin and get another in better condition. (Pic. K) shows it all looking nice and neat ready for reassembly.

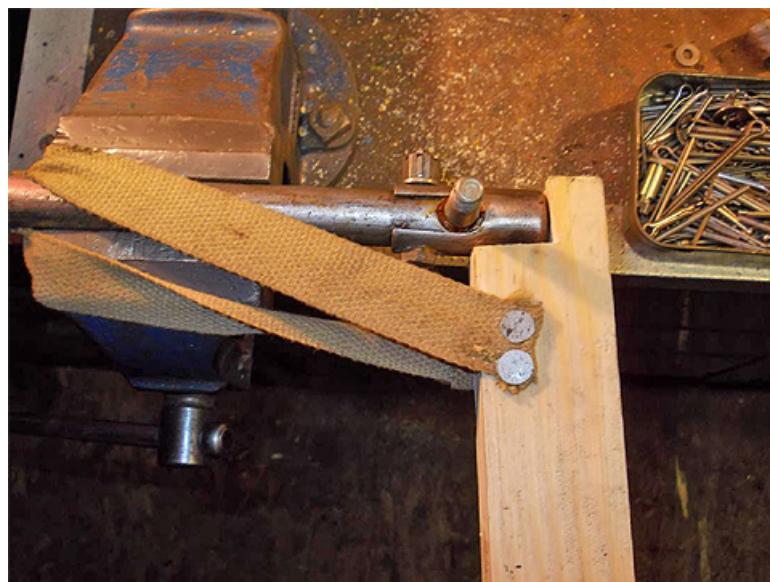
Pic. L

At this point note if the thrust block is sticking out proud from the end of the tube or just flush with the end, if this 'is' the case fit the chamfered thrust disc into the end cap (chamfer facing the end of the cap) a blob of 'Vaseline' is good for keeping it in place. If the distance piece was missing from your assembly you will need to make one up, they are around $\frac{1}{8}$ " thick (not sure if new ones are available).

Slide the cap on to the tube until it touches the end of the thrust block. Observe the relative positions of the bolt holes in the tube and cap, add or remove shims or washers until the bolt hole in the cap has just gone 'past' the hole in the tube by 1/32" i.e. if you then pull it back 1/32" and put the bolt in the joint will rattle slightly. If this has gone to plan remove the cap and shims and put to one side for reassembly. Put the new spring into the end of the thrust block, check that the spring sticks out from the end of the block by 1/8" to 3/16", using a piece of wood or hammer shaft push on the spring making sure the whole of the spring will fit into the block and is therefore not spring bound, if it was it would make the joint solid rather than sprung as designed. Reassemble the parts using my lever arrangement in (Pic. L) putting 'copperslip' anti-seize on the thrust block sides and normal LM grease on the ball pin. Bolt up and secure with a new split pin.
