Bristol Austin Seven Club

Bristol Austin 7 Club - technical article

Torque Tube mounting bush - post 1935 - Dan Cole

Silent block - Bush removal tool. A handy gadget for those with later cars fitted with this 'modern' rubber bonded bush.

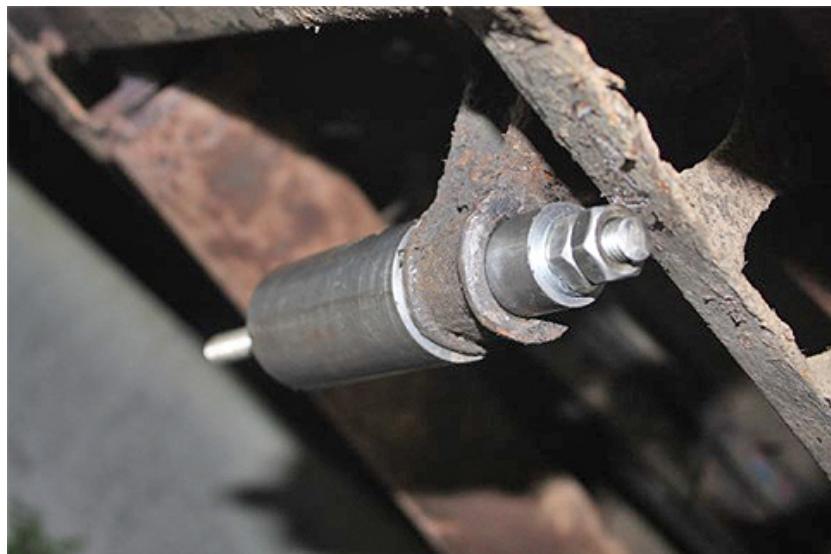
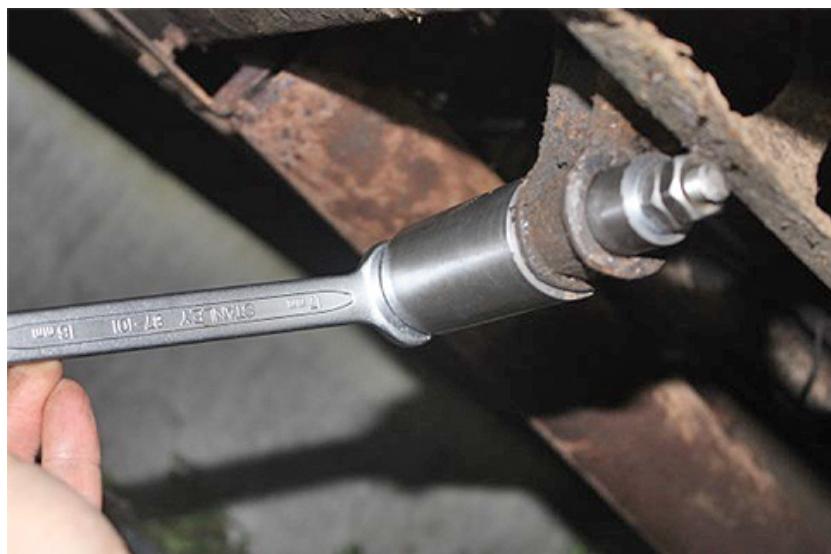
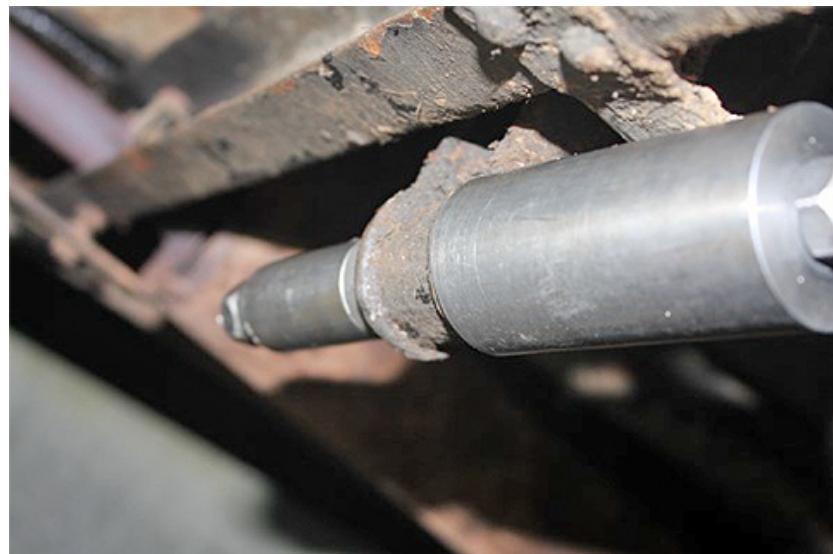
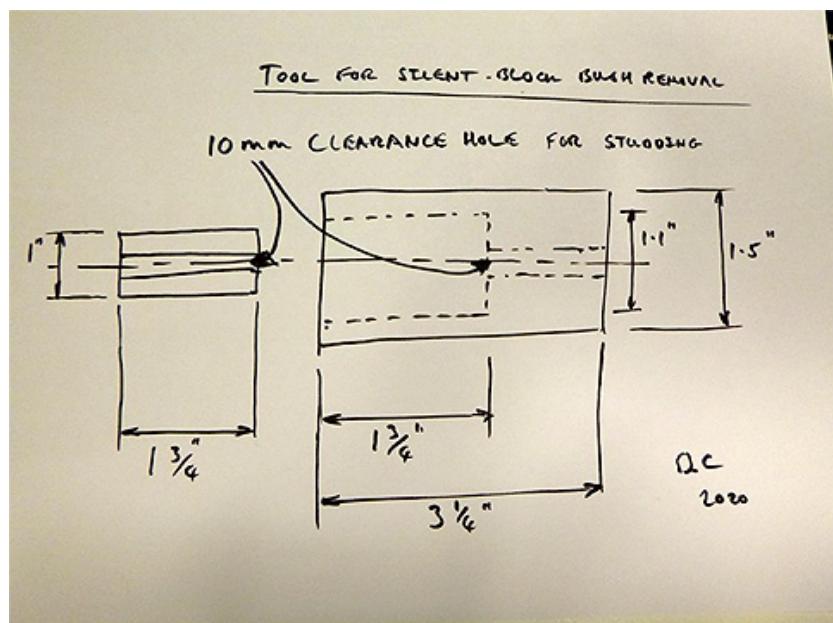
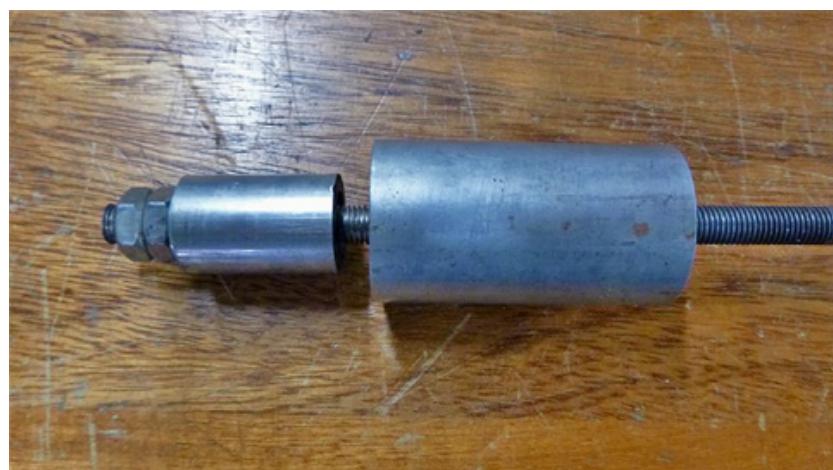
To do the job in situ I made up a simple puller tool made of 2 lengths of steel bar, turned up in the lathe so that the larger part (essentially a tube) could bear upon the outer housing and the smaller part would press on the outer part of the bush. Force was applied using threaded bar with a nut. To obtain access and use the tool I had to remove the bracket that secures the bush to the chassis but this did not put up much of fight. The tool worked well but the bush was predictably tight in the housing - to the extent that the M10 studding was only just up to the

job (sorry – a modern thread was used - 3/8" BSF would have been more appropriate and given a bit more mechanical advantage).

Hopefully the accompanying pictures tell the story better than my blurb. It turned out that the bush was the source of the racket, and the new one transformed the car. All the other noises persisted but those from the transmission were no longer being amplified by the body via the rattling bush. If anyone needs to do the same job and doesn't have access to the required bits of tube or a lathe to turn them up they are welcome to borrow it – so long as I get it back of course !
