Bristol Austin Seven Club

Bristol Austin 7 Club - technical article

Wiper motor, DW3 - improvements - Sandy Croall

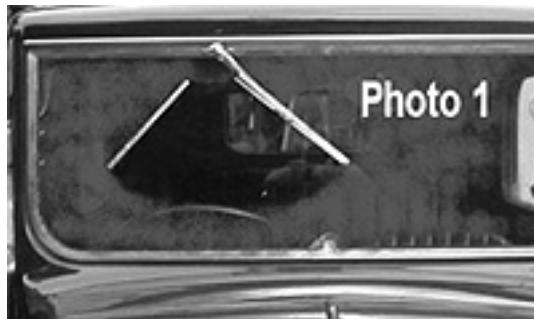
My first venture into the rain was not good, the motor worked, but the swept angle was only 90° - *Photo 1*, and I could not see much to either side of the car, bearing in mind I sit rather high in the car. I did temporarily alter the gear inside

to give a better view on the offside, but found I could then see nothing to the nearside. I thought this was a retrograde step, the vacuum wiper had given a swept angle of at least 130°.

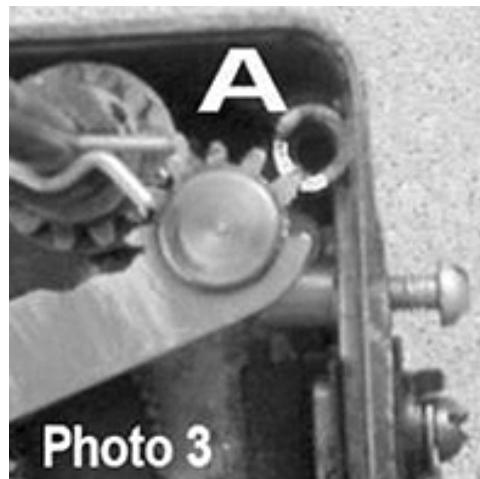
However this then meant the gear teeth on the end of the pivot arm hit the tube moulding 'A' - *Photo 3*. I removed this area low enough to clear the teeth. The original position reached by the pivot arm is shown in *Photo 4*, 'B' is the new bearing hole, 'C' is the original. The revised arrangement gave a swept angle of just under 170°, as shown by the positions of the 'R' pin in *Photos 6 and 7*. However once this is transferred to the wiper blade and the mechanical losses are taken up there is about 135° of swept angle on the windscreens – see *Photo 5*.

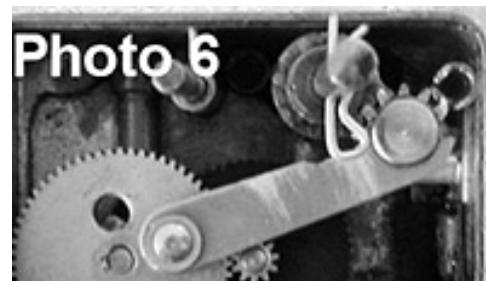
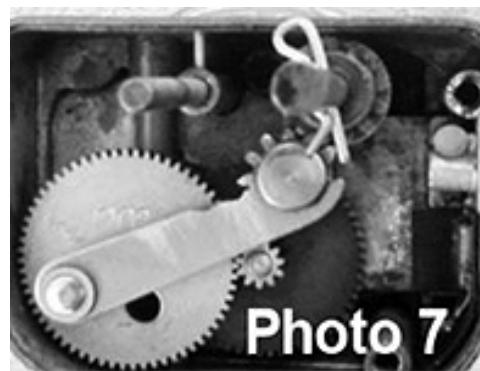
However, you may also be frustrated by the narrowness of the sweep that is made by the wiper arm. The article below shows how this can be widened by slightly increasing the radius of the crankpin on the large gearwheel.

I can now see where I'm going when it rains, but they say this is going to be one of the driest summers ever, in fact there are already hose pipe bans..... Just as an aside the DW3 gear wheel is marked 120° and indeed it does sweep about 120° in the motor, it's the mechanical losses that end up as 90° on the windscreen.
